Inventory No. 86A-27-44

Maryland Historical Trust Maryland Inventory of Historic Properties Form

1. Name of I	Property	(indicate preferred	name)		
historic					
other	Donovan Toba	cco Barn			
2. Location					
street and number	10401 Croom I	Road		_	not for publication
city, town	Upper Marlbor	0			vicinity
county	Prince George'	S

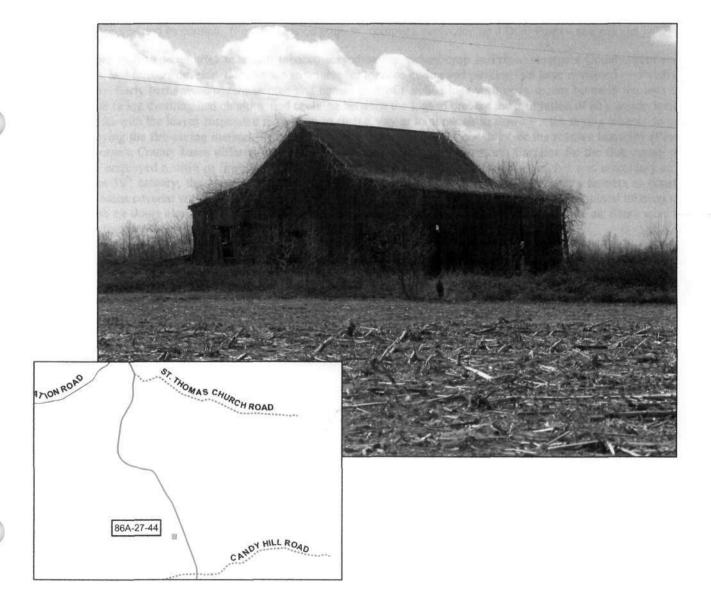
Sited on a rise in the middle of an open field to the west of Croom Road, this tobacco barn appears to date to c.1830.

The wood frame structural system is clad in vertical boards and the gable roof is covered with sheets of standing seam metal. The barn has a central rectangular form with sheds on the north and south elevations. Although this form dates to c.1800 - 1830, this barn is dated to c.1830 as the gable pitch is not as steep as seen in other early barns. Hinged vertical air doors line the north and south elevations. Double and single-leaf vertical board wood doors provide access to the barn. The barn is currently overgrown and deteriorating.
